Channel Stability Problems, Pajaro River, Watsonville and Pajaro, California

**U.S. Army Engineer Committee on Channel
Stabilization Report of the 63rd Meeting**

ERDC/CHL SR-00-3
CCS-00-1
August 2000

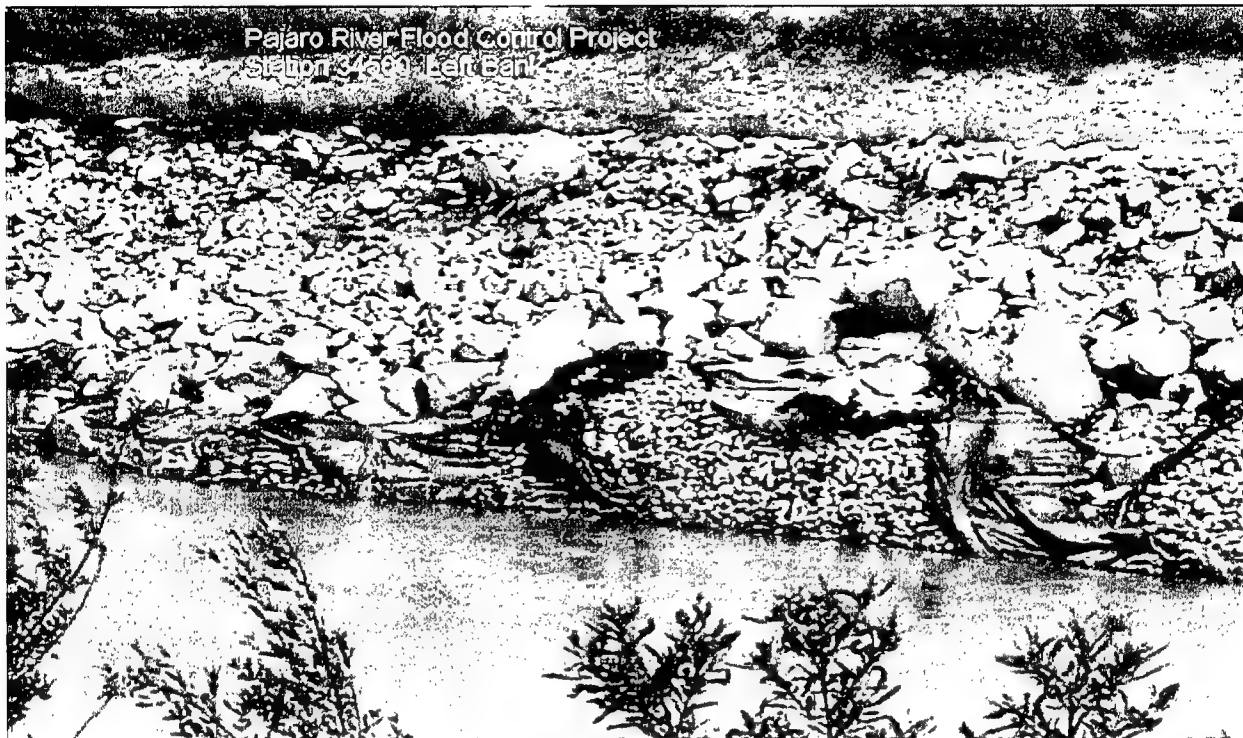
Figure 6. Incorrect installation of erosion control mats

- c. The locations where the banks have been stabilized are very steep. Also, the stone, although apparently well graded, is inconsistent in size. The erosion control mats have been installed incorrectly and/or have been applied to situations for which they were not intended (see Figure 6).
